STABILITY ANALYSIS

SS WAPAMA

BARGE "214"

RE: Reference 8140-85-Q-0022
Barge 214 Report
of Condition.
Survey at Merit Ship
Repair and Dry Dock Oakland
CA, on date 5-31-85
and subsequent dates.

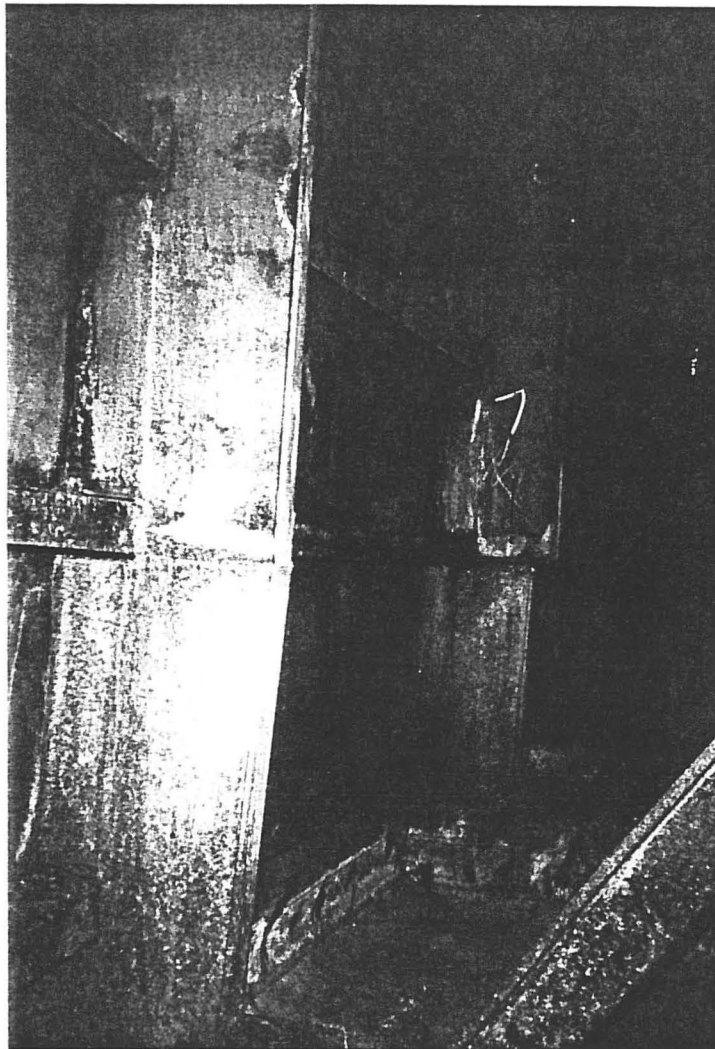
SFH 85129
Page 1,
Photo #1,
Frames not welded completely.

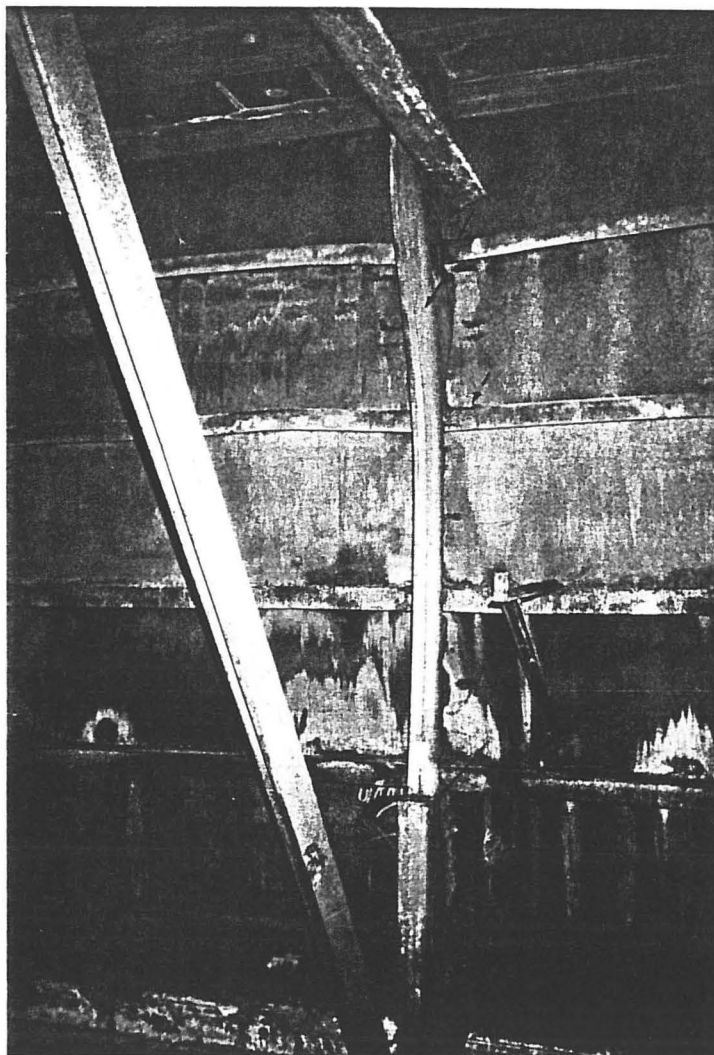
Middle: Deflection in longitudinals

Lower: Frame not rewelded

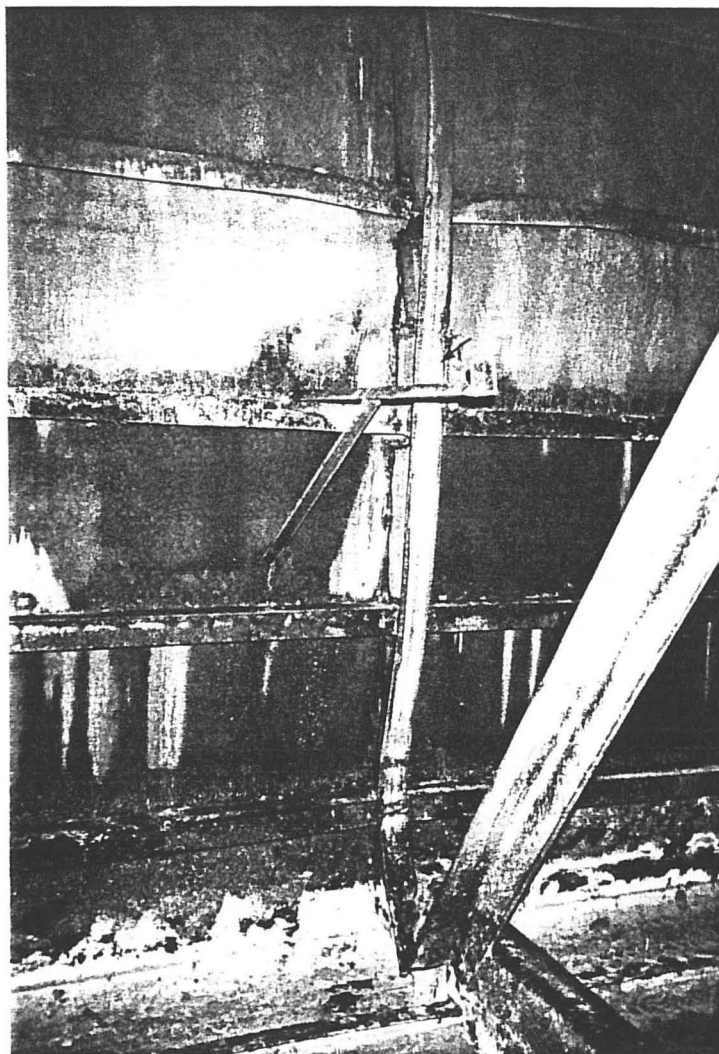
Photo #3,

Present vessel condition as found in this report of survey indicates that most shell plate distortion due to the event was left as is. Damaged frame work was removed and new frames and bulkhead sections were added, scribed to fit the contours of the distorted shell plate.

Frame scribed to fit distorted shell plate.

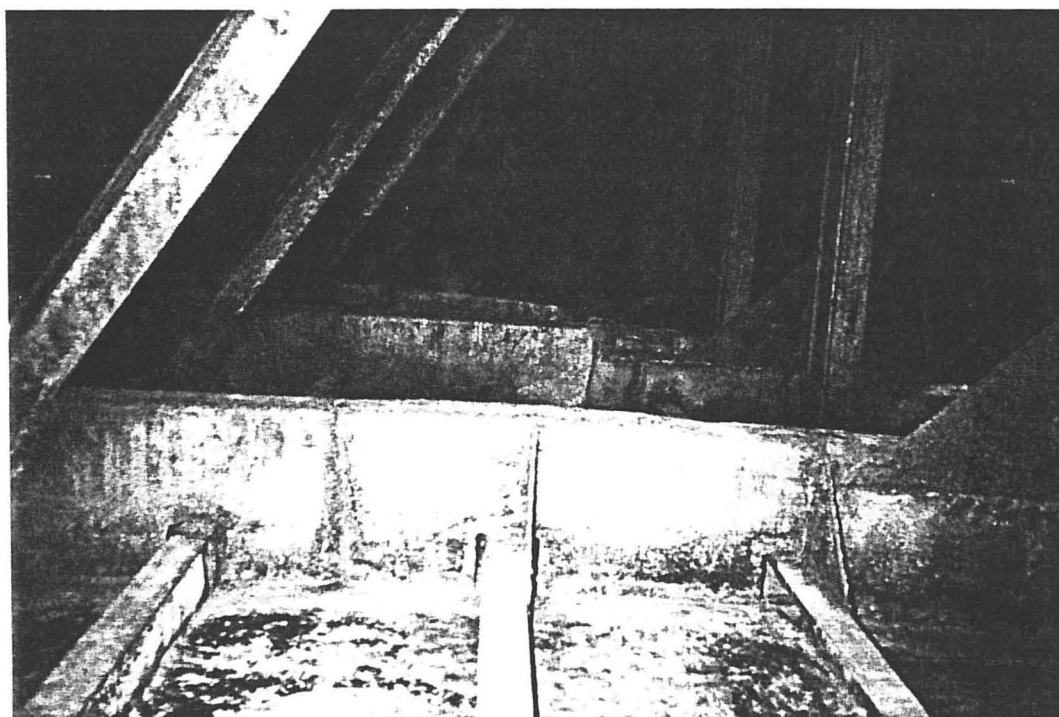
Photo #4,

Distortion in bottom frames, scribed to fit.

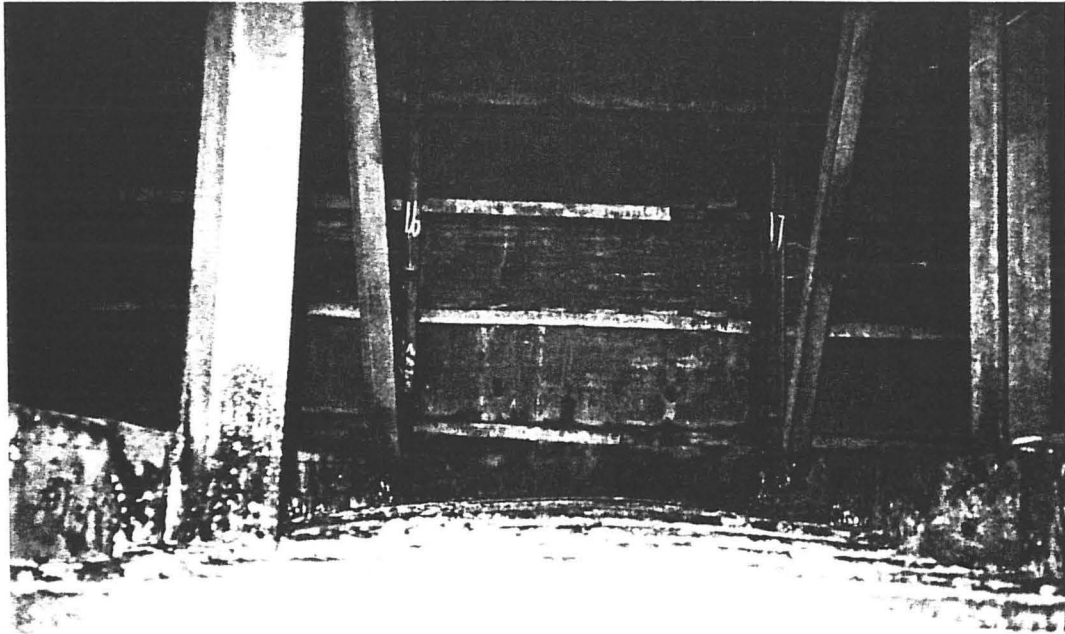
Photo #5,

Bottom distortion, frames scribed to fit.

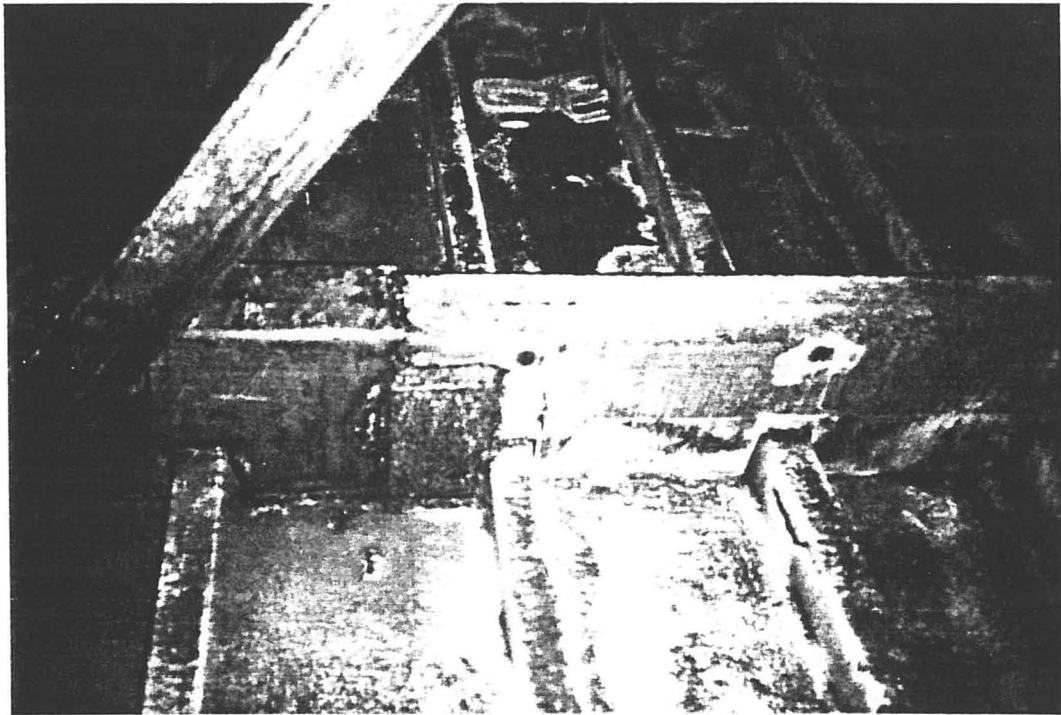
Photo #7,

Side shell with frame scribed to fit.

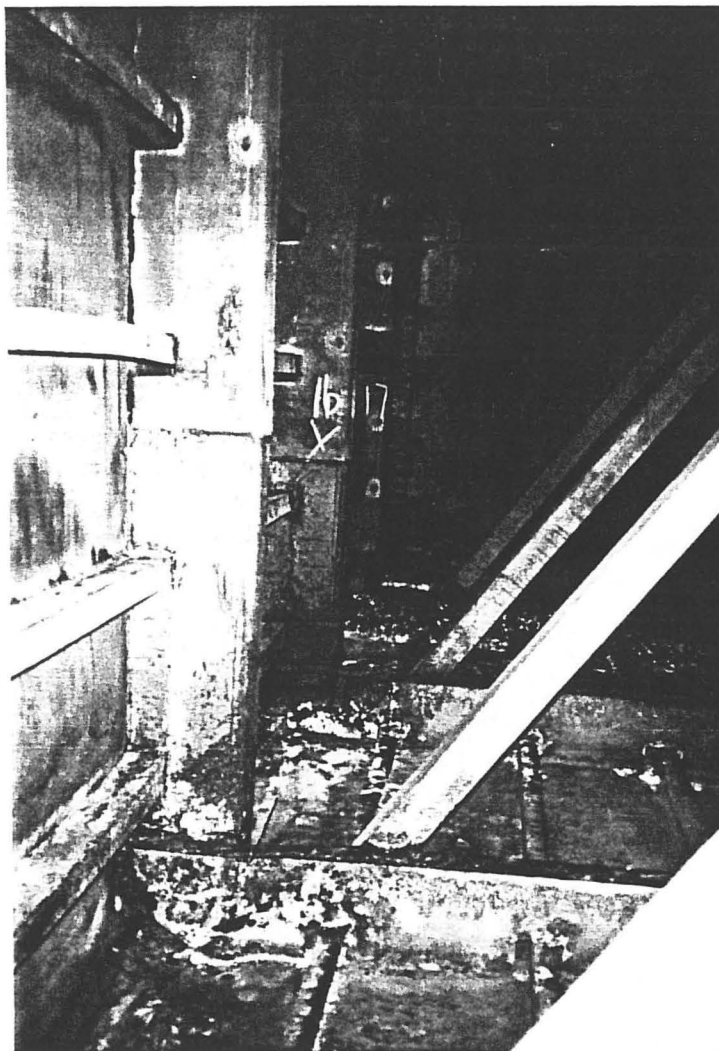
Photo #8,

Bottom frame distortion, side shell frames scribed to fit

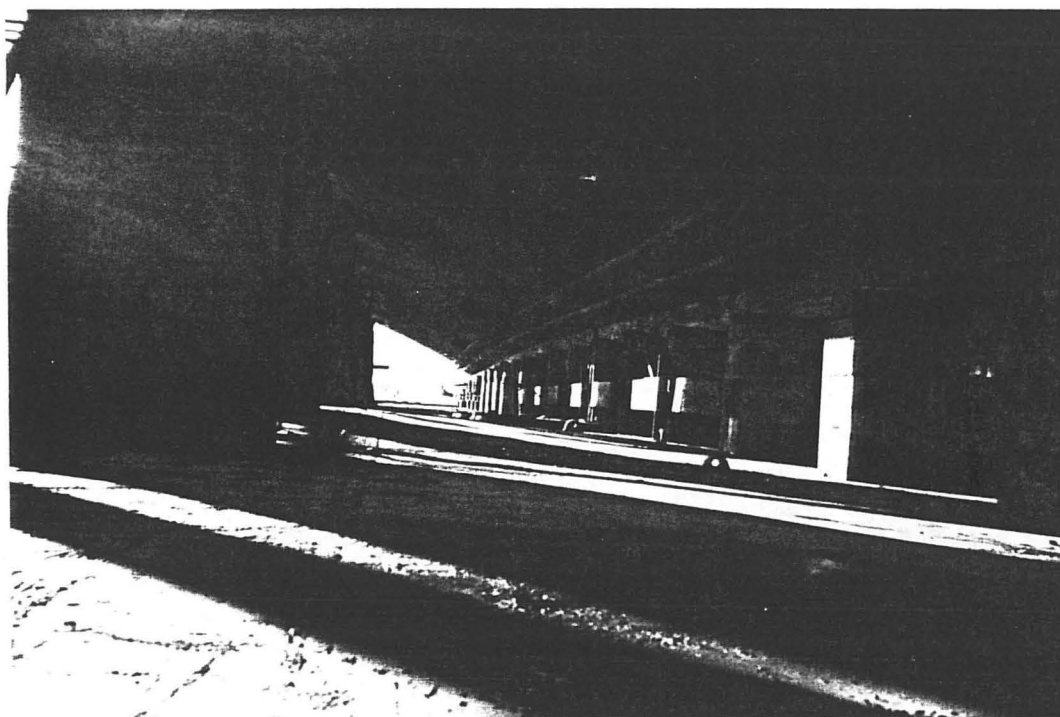
SFH 85129
Page 9
Photo #9,
Deck upset port side.
